A consideration of operational risk for slope disaster in the NOTO Peninsula earthquake

Tomoo Dobashi¹, Sadao Kimura²

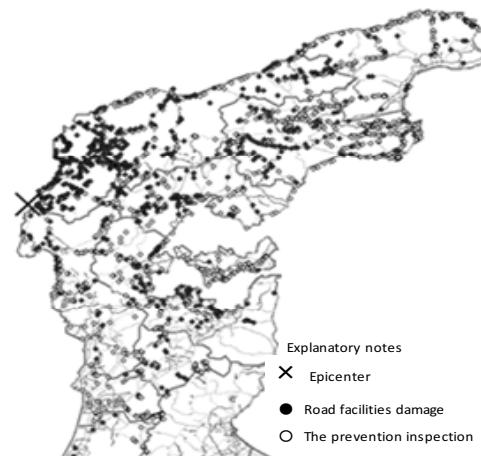
Fig.1 Road facilities damage spot by the NOTO Peninsula earthquake

The natural disaster such as an earthquake or the typhoon occurs in Japan. And in late years, large-scale natural disaster occurs. In March, 2007, NOTO Peninsula earthquake (M6.9) occurred. By this earthquake, the damage amount of money of the whole civil engineering facility was about 24,200,000,000 yen. In particular, the damage amount of money of the civil engineering facility is about 19,300,000,000 yen and occupies about 80% of the total damage amount of money¹⁾. Figure 1 shows the damage point of road facilities by the NOTO Peninsula earthquake.

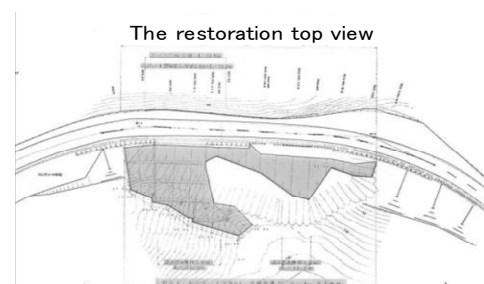
Fig.2 A figure of restoration top view of the disaster spot

It is necessary to identify a damage location and the prevention inspection point in detail to grasp a slope disaster by the earthquake. The prevention inspection point is already grasped in latitude longitude. Therefore, we identify the position of a disaster location and the prevention inspection point. Figure 2 and figure 3 showed the example of the data which used for the identification. About 83% slope damage understands a thing than this besides a prevention inspection point. The comparison result of the identification of the damage point and the prevention inspection point is given in table 4.

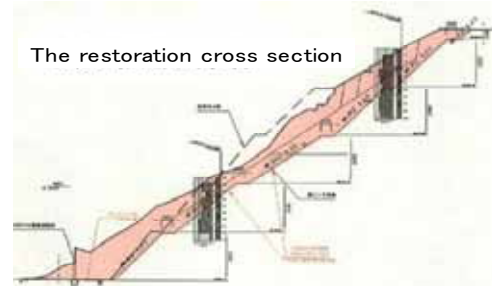
Fig.5 The restoration cross section of the disaster point that we judged the slope of failure

In the case focused attention on the number of slope disaster and restoration cost, a ratio of "Correct" and "S-Incorrect" change greatly. To investigate of the above-mentioned cause, the number of 58 slope disasters are classified into three kinds "Slope of failure", "Natural hill of failure", and "Surface deformation". The classification of the slope disaster uses the restoration top view and the restoration cross section of the damage point. We show below the example of the restoration cross section of the disaster spot that we spoke by the above. As for figure 5, the slope of failure, figure 6 the natural hill of failure, figure 7 as surface of deform.
