Consideration about reliability improvement of picture photography technology in inspection of tunnel lining

Hajime Jyoduka¹, Toshio Suzuki², Sadao Kimura³ and Mamoru Moriyama⁴

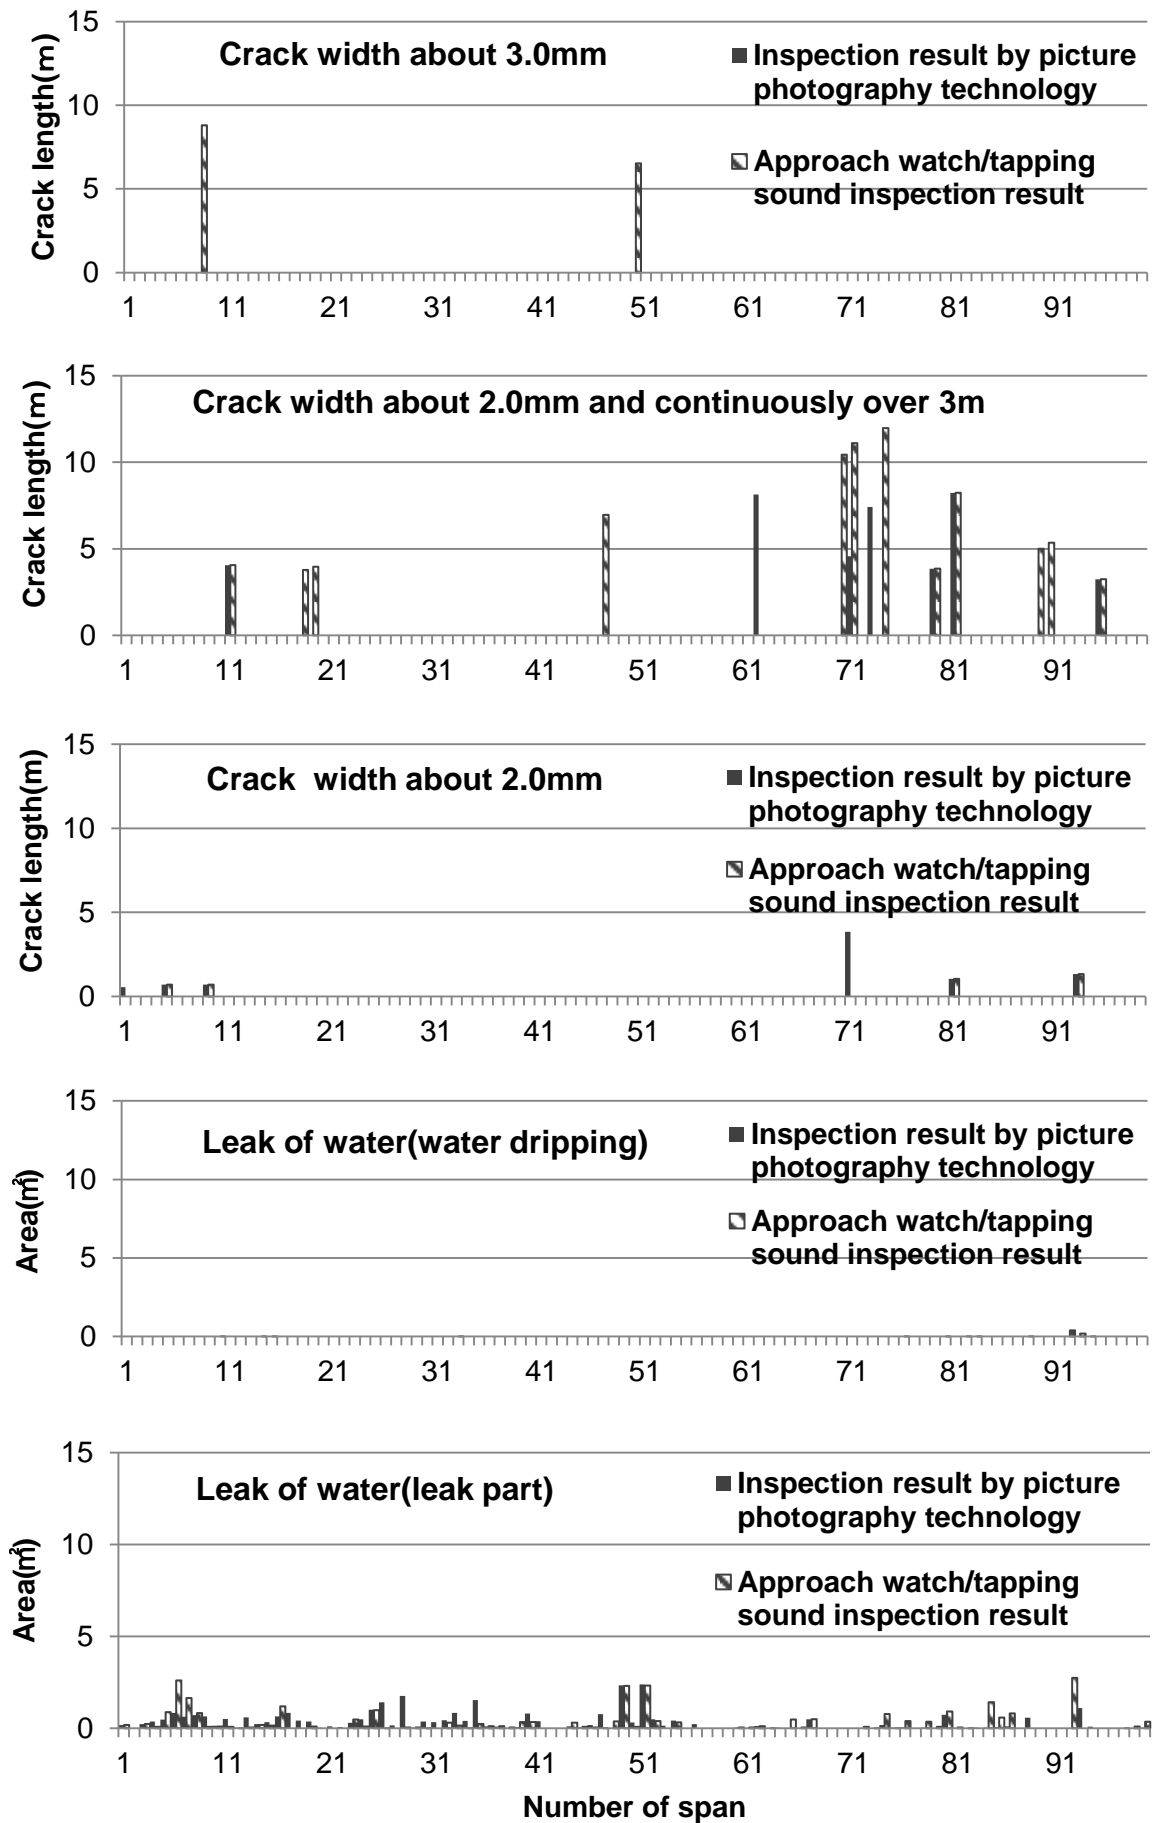
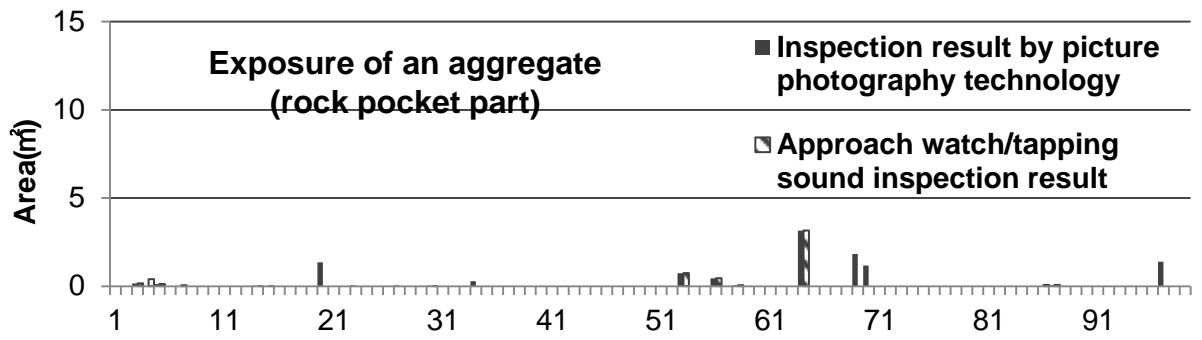
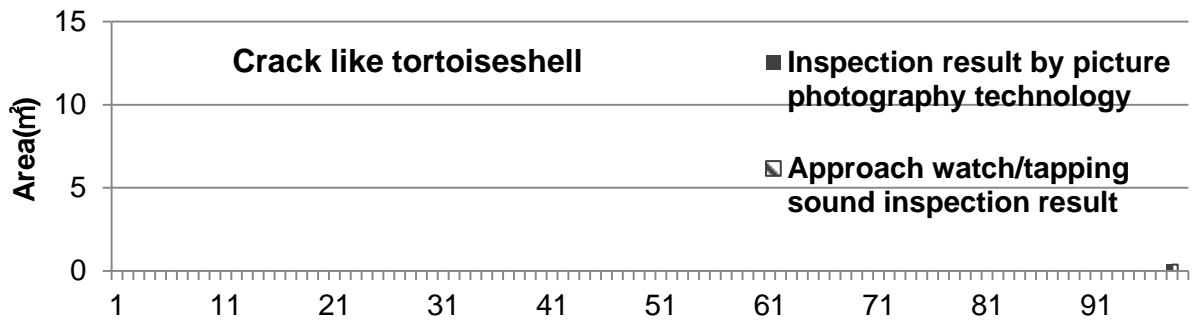
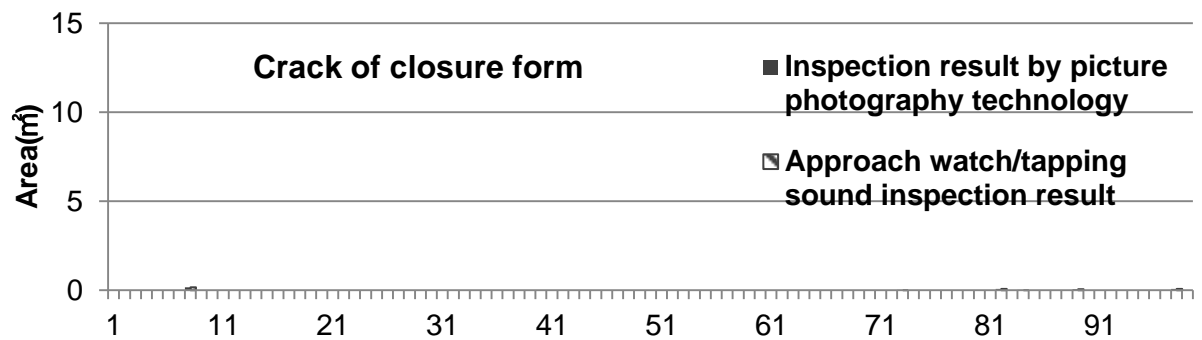
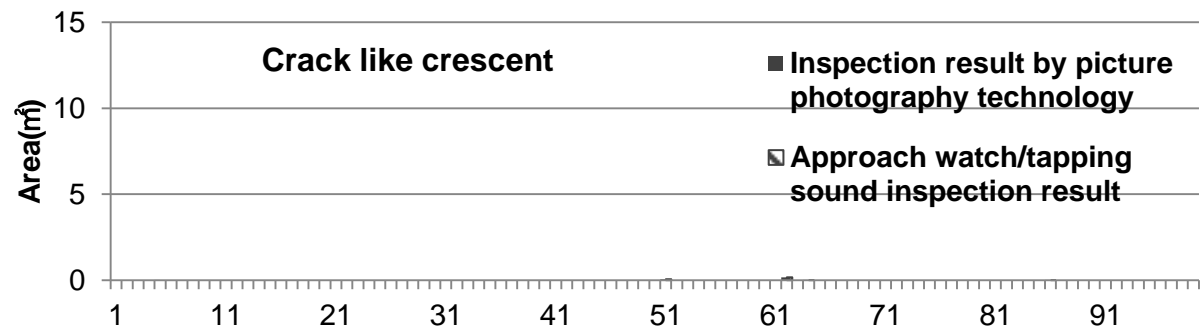
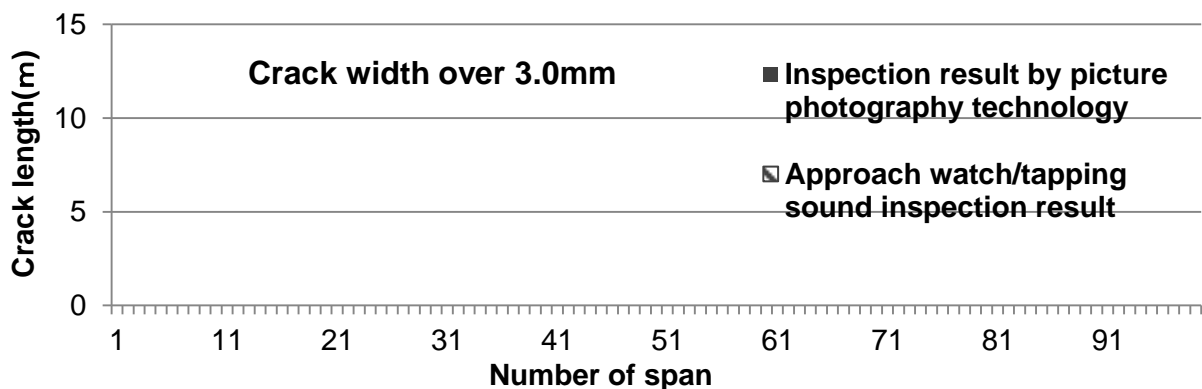
Figure3 Inspection results of A tunnel

A result of the picture photography technology and approach watch/tapping sound inspection in A tunnel are indicated on figure 3. Equally, a inspection result of the B tunnel is indicated on figure 4. Vertical axis is the size of the damage. Transverse axis is the span number. A damage of inspection by picture photography technology of the inspection index of tunnel lining indicated in inside front, inspection data was put in order every item. A damage of large size crack and middle size crack indicated in classification of a damage, the size of the item is expressed in extension. Other damage, the size of the item is expressed in the area. A crack like tortoiseshell, a closure crack and a crack like crescent, it's record a circled area in a

There is back hollow in A tunnel, but there are no B tunnels. When the detection amount of the leaking system is seen, there are B tunnels a lot more than A tunnel without the back hollows. The thing inspection by picture photography technology is detecting big finds out but that a result of the approach watch/tapping sound inspection is seen.

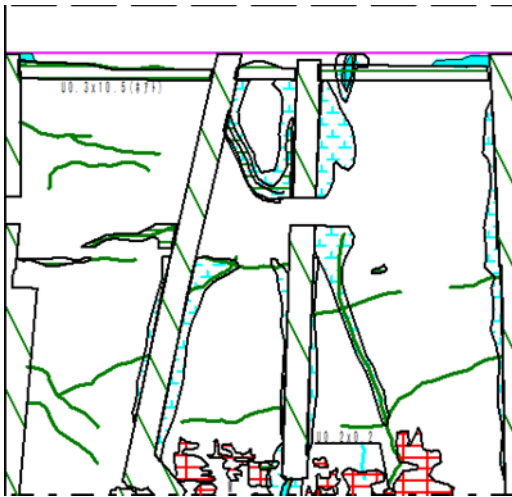
Figure5 Lining development of inspection by picture photography technology

When a lining development on figure 5 is seen, I find out that only inspection by picture photography technology is detecting exposure of an aggregate (the rock pocket part). The other spans also analyzed inspection result in a target by a similar way. When it was analyzed about the item of the crack course, progress of a crack was the damage and that detected around the crest in a tunnel, and was here, and developed in the crossing direction, influence was relatively and detection in a margin found out that it's frequently.

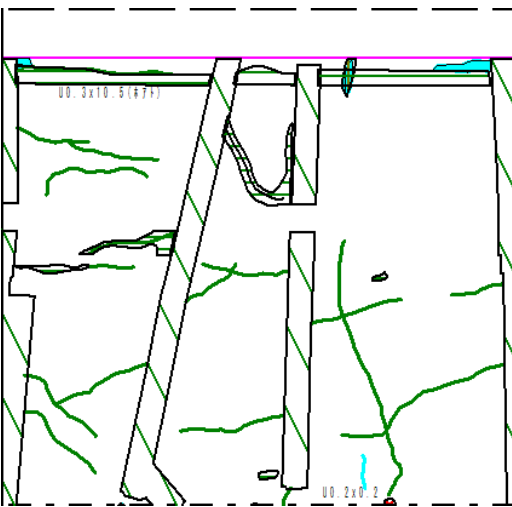
Figure6 Lining development of approach watch/tapping sound inspection

The detection point of view of the damage of tunnel lining as well as the size of the strange document and a crack are considered from information on the way of the damage here. The point of view of the damage detection and the way indicate the part of the lining development which can be confirmed on figure 5 and 6. Figure 5 indicates the lining development inspection by picture photography technology gives. Figure 6 indicates the lining development approach watch/tapping sound inspection gives. Figure 5 and 6 show the situation of the lining surface of number of 5 spans in a B tunnel. A lining development is made in case of two inspection. The state of the tunnel lining surface was mapped. A list of the damage expressed in a lining development is indicated on figure 7.
