A consideration of operational risk for slope disaster in the NOTO Peninsula earthquake

Tomoo Dobashi¹, Sadao Kimura²

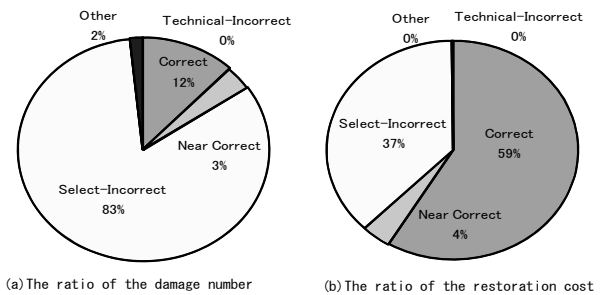
Fig.4 The ratio of the slope disaster of the "Correct" and "Incorrect"

The comparison result of the prevention inspection result and the damage result is given in table 6. As for the slope disaster, the numbers of 7 were "correct", and the numbers of 48 were "S-incorrect". Next, we clarify a restoration cost at each evaluation of the prevention inspection result. Table 7 shows the restoration cost at each evaluation of the prevention inspection result. As shown in figure 4, represents a ratio of the number of "Correct" and "S-Incorrect", in the case focused attention on the number of slope disasters and restoration cost. As shown in Figure 4(a), represents the ratio of the number of each "Incorrect" and "S-Incorrect", in the case focused attention on the slope disaster number. As shown in Figure 4(b), represents the ratio of the amount of money of each "Incorrect" and "S-Incorrect", in the case focused attention on the restoration cost. As shown in figure 4(a), the ratio of "Incorrect" accounts for about 15% of the total, and

"S-Incorrect" accounts for 80%. On the other hand, as shown in figure 4(b), the restoration cost of "Incorrect" accounts for about 60% of the total, and "S-Incorrect" accounts for about 40%.

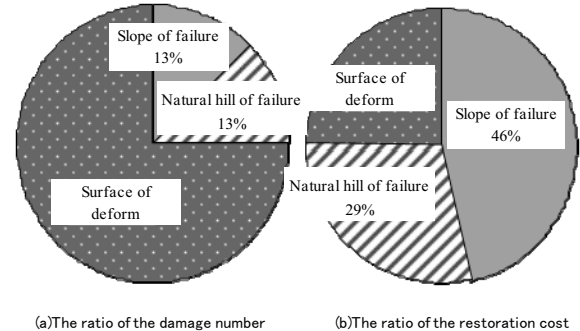
Fig.8 The classification result of the slope disaster in the "Select-Incorrect"

As shown in figure 8(a), show the ratio of the result that classified of the slope disaster in the total number of "S-Incorrect". In addition, figure 8(b) show the ratio of the restoration cost in the total number of "S-Incorrect". In the case focused attentions on the slope disaster number, surface of deform holds about 75% of the total. From this, it became clear that a lot of surface of deform that the restoration cost was occurred by the NOTO Peninsula earthquake. On the other hand, in the case focus attention of a restoration cost, the surface of deform holds about 25% of the total.

However, in the case focused attention the number of disaster, about 80 percent of all was damaged out of the prevention inspection point. And about 70% of disaster out of the prevention inspection point was surface of deform. In the case focused the number of slope disaster, there is room for the improvement at the surface of deform of the prevention inspection point.
